# District of Highlands

## 2024 Asset Management Plan

November 2024

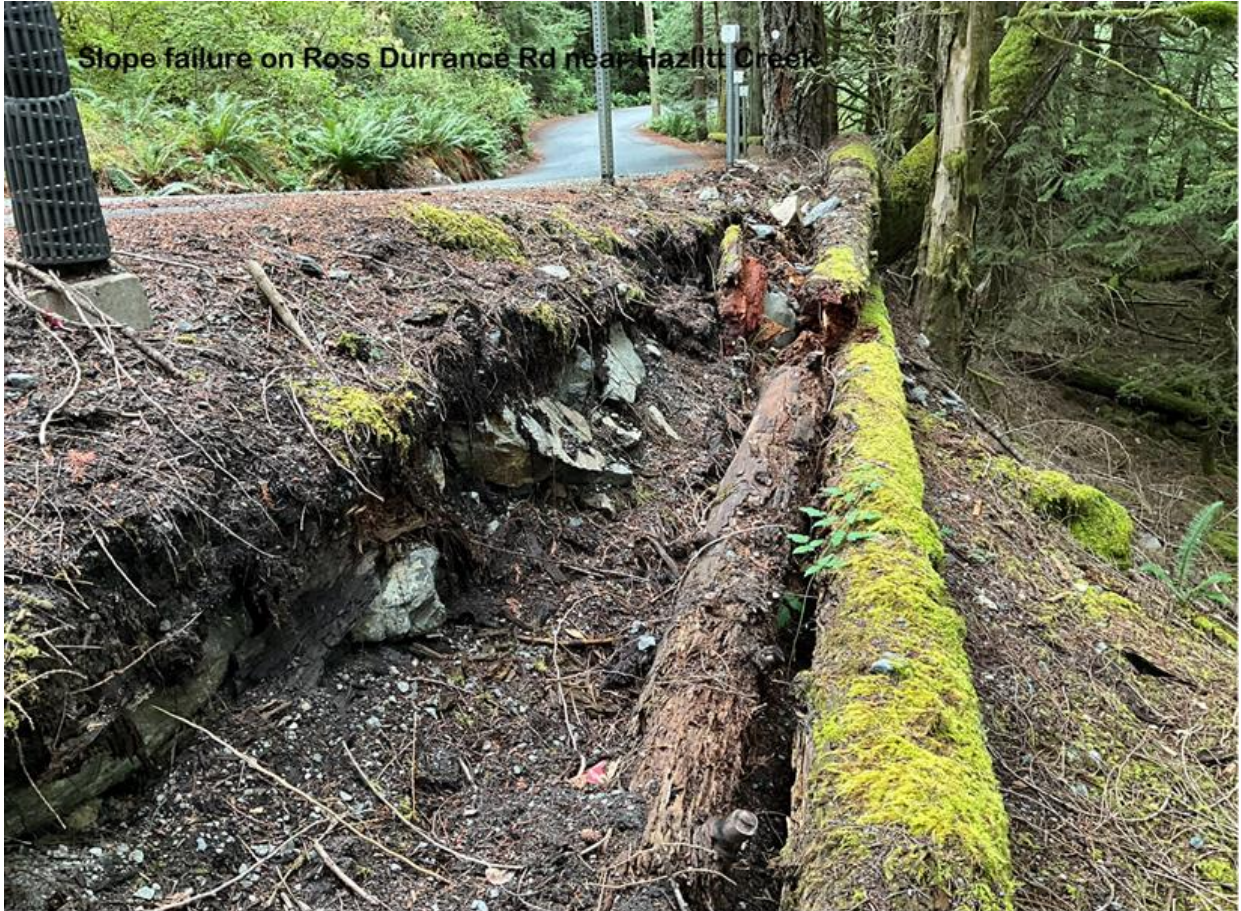
Since 2016 two slope failures have occurred in the Ross Durrance/Millstream Lake Road area of corduroy road construction, indicating a possible deterioration in the road base. The most recent was discovered in 2024 and estimated to cost between \$150,000 and \$200,000 to repair in 2025. Proactively rebuilding of road base in this area is not practical or financially feasible for a municipality of the District's size.

Repairs will be made reactively as conditions require or as failures occur. This will impact on the level of funding available for paving in the year that repairs occur.

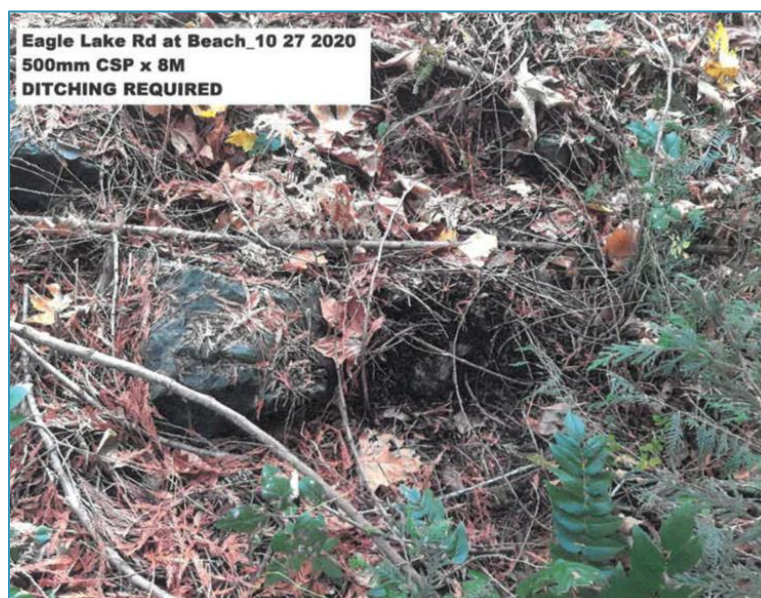
Half (46%) of the culverts are in very good condition, a small number are in fair condition but 50% are in very poor condition. Replacement of 110 of these culverts is very likely over the next five to ten years.

Given the number of existing culverts that are significantly through their service life and in poor condition a robust replacement program to replace them all, worst first, over the next ten years is required.

1. Establish a ten year culvert replacement program funded from Canada Community Building Fund, LGCAP and Growing Communities Fund Reserves.
2. Increase property tax funding for culvert replacement to a minimum of \$199,000 per year.
3. Complete the deferred maintenance program.
4. Continue to field assess culverts annually.

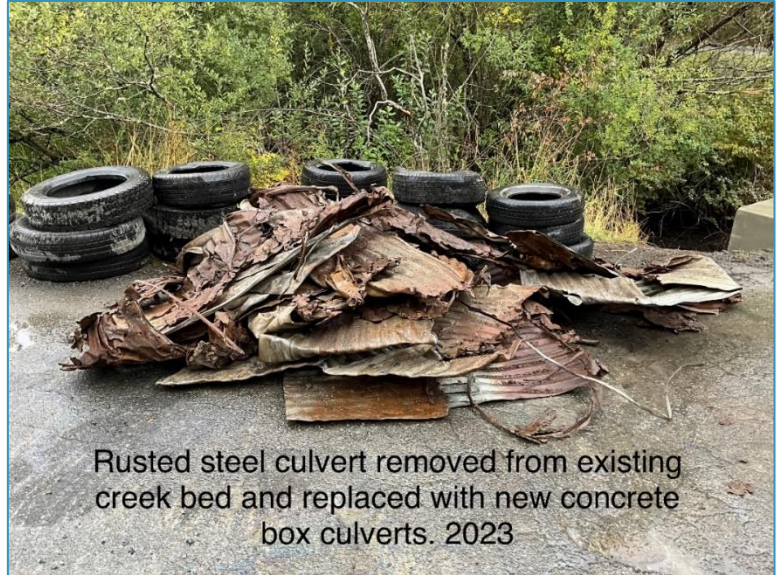
Rusted steel culvert removed from existing creek bed and replaced with new concrete box culverts. 2023

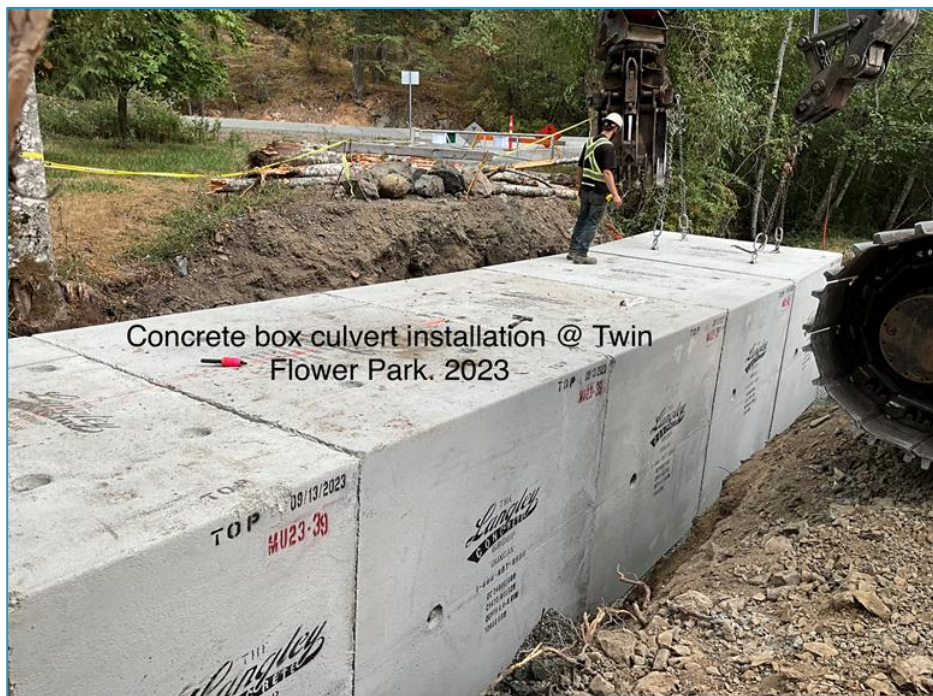
Concrete box culvert installation @ Twin Flower Park. 2023

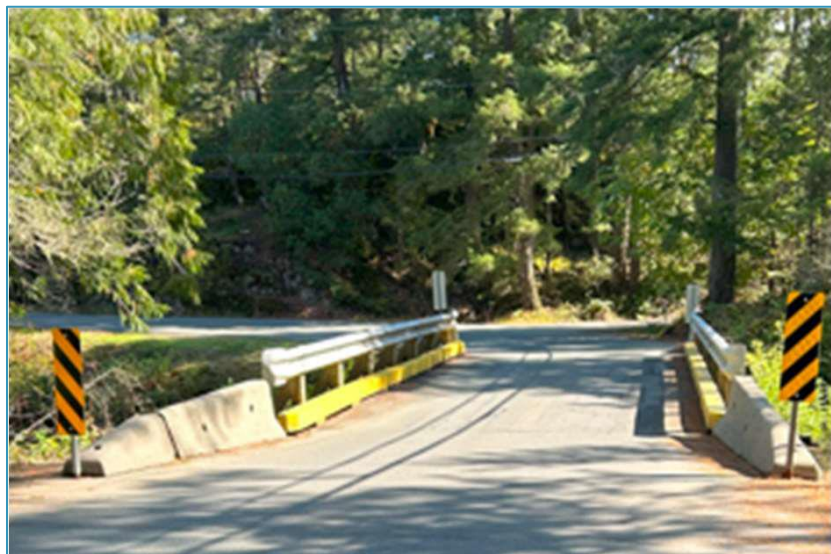
Bridges are in good to fair condition based on the 2024 Herold Engineering assessment, apart from Hanington Bridge which is in fair to poor condition due to sealant deterioration and mortar debonding and Corry Bridge due to significant undermining of abutment footings. No significant structural

deficiencies of immediate concern were noted during the assessment.

1. Complete the structural and maintenance repairs recommended by Herold Engineering in 2025.
2. Increase annual asset replacement funding to \$86,000 per year over the next five years.
3. Continue to assess bridges on a bi-annual basis as required for safety and insurance purposes.
