The Highlands Lime Kiln: A Historical Archaeological Inventory Assessment

Prepared for:

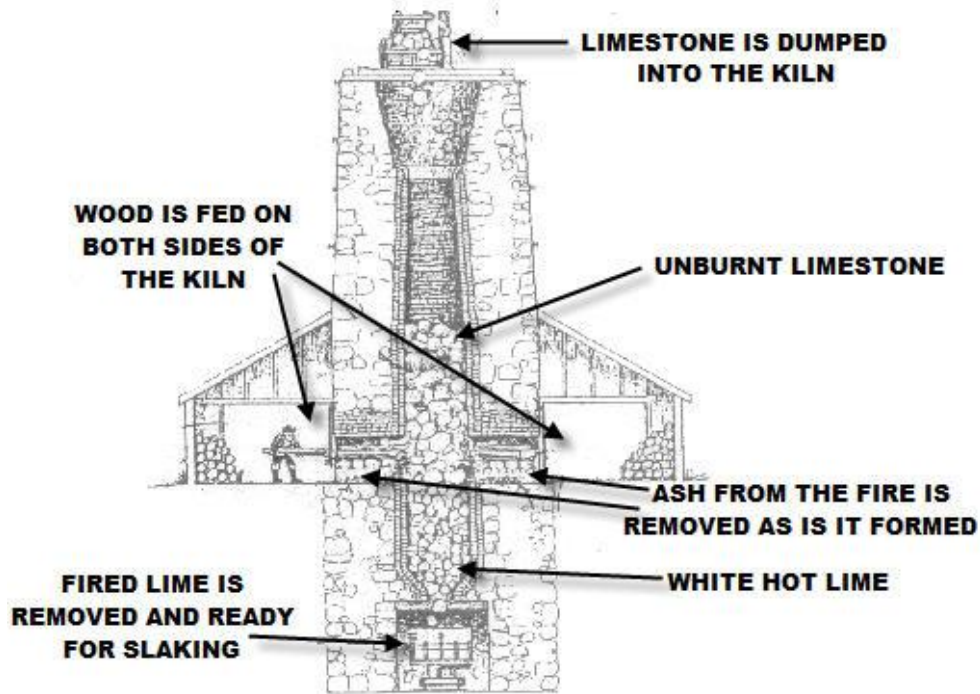
Figure 3. Cross section sketch of a vertical draw lime kiln (Grafton Lime Kiln, limehousekilns.ca).

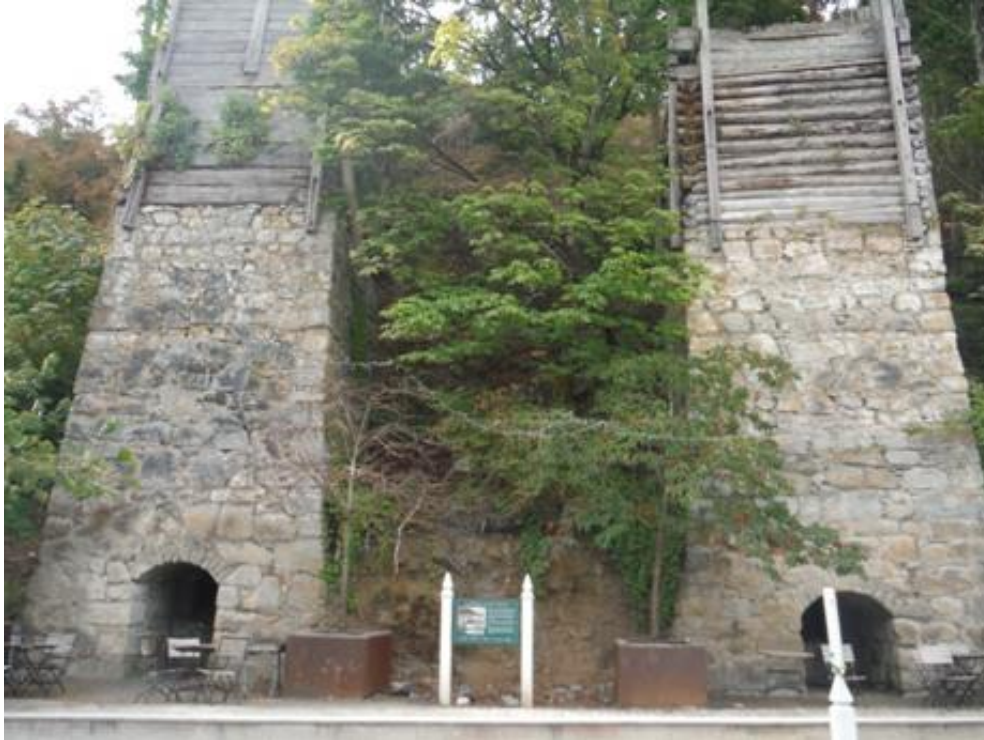
Figure 5. Large scale lime kiln operations at Roche Harbour, San Juan Island (photo by author).

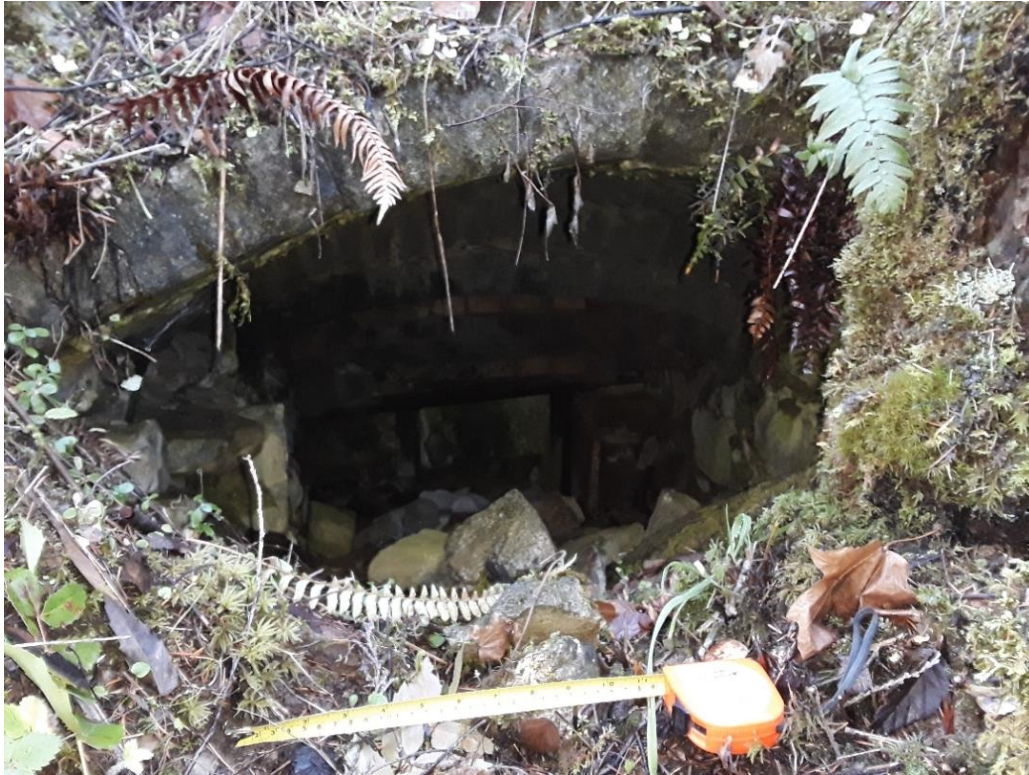
Figure 9. Front drawhole entrance.

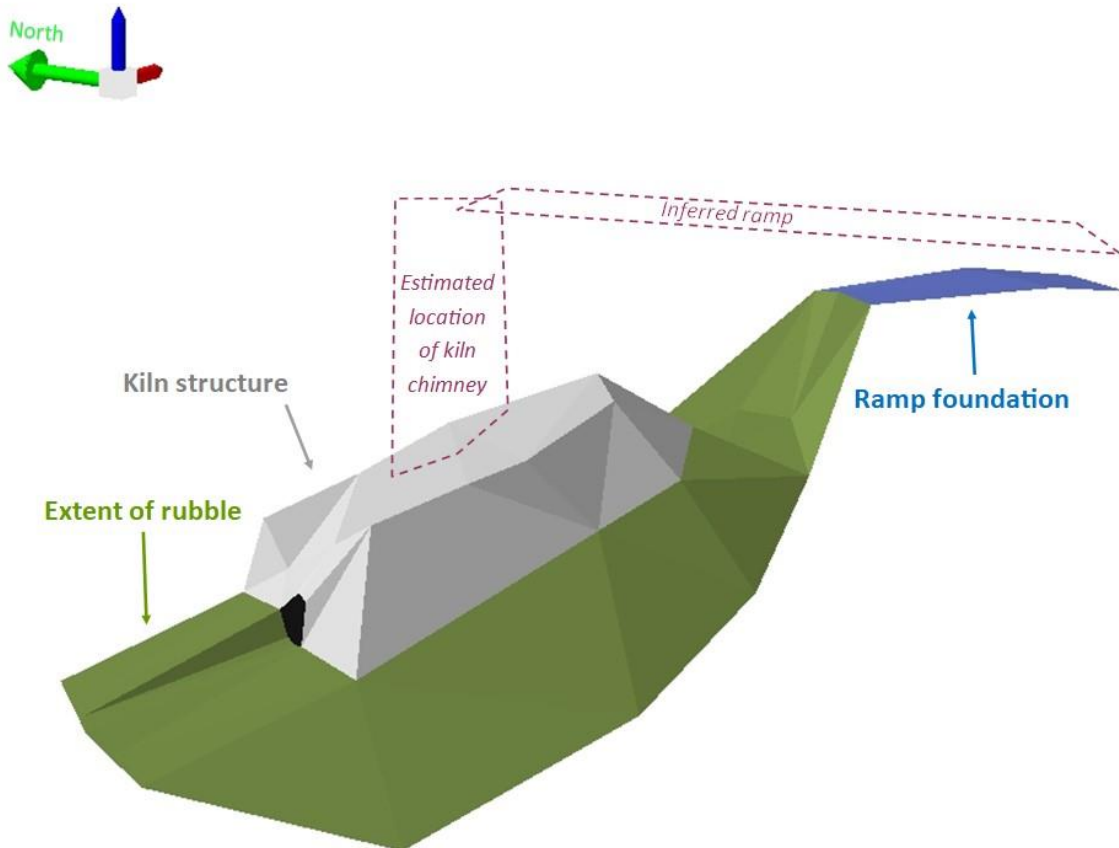
Figure 11. Three dimensional model of the Highlands lime kiln, view looking to the north.

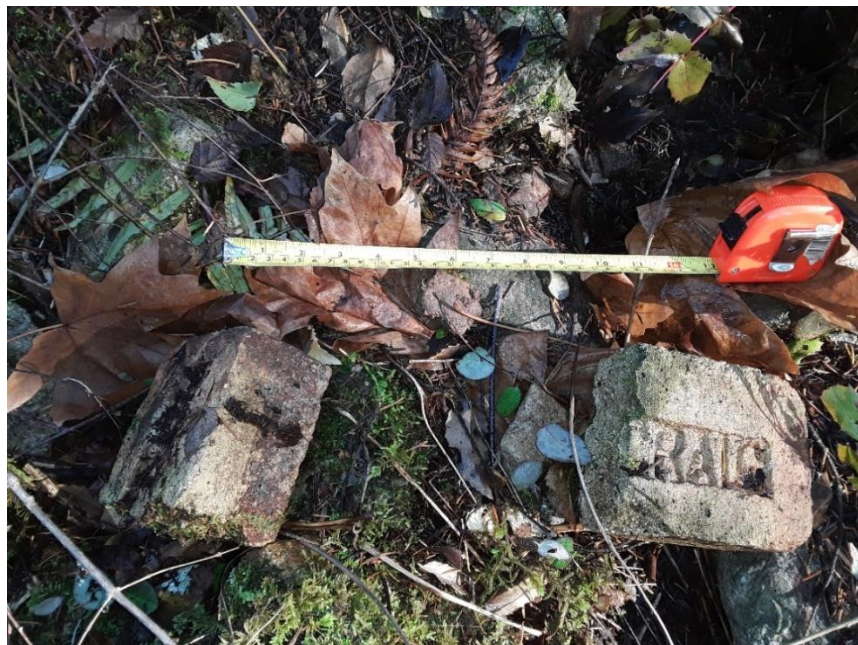
Figure 14. Gartcraig brick fragments recorded on surface of kiln.

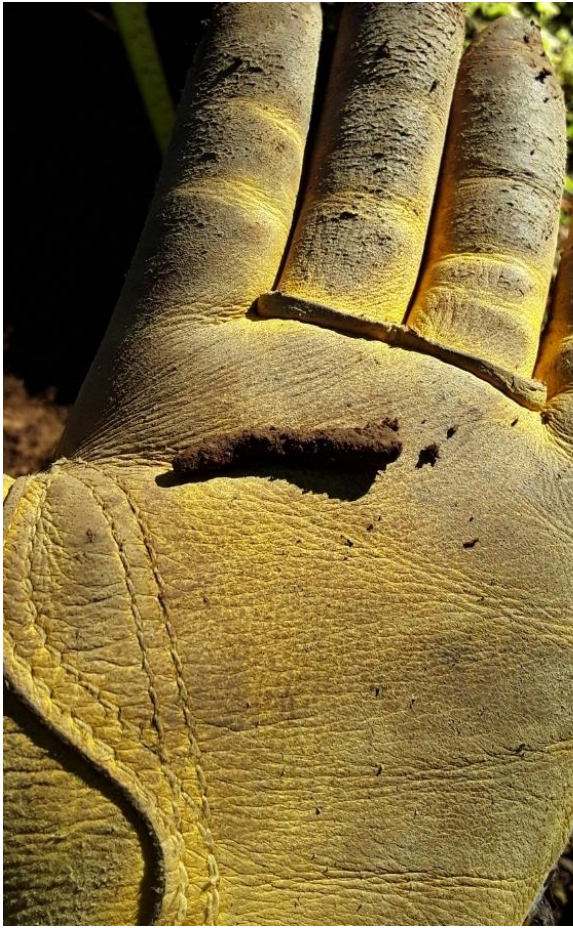
Figure 16. Square nail from ST-6. Likely from the wooden ramp structure for dumping limestone into the kiln for burning.

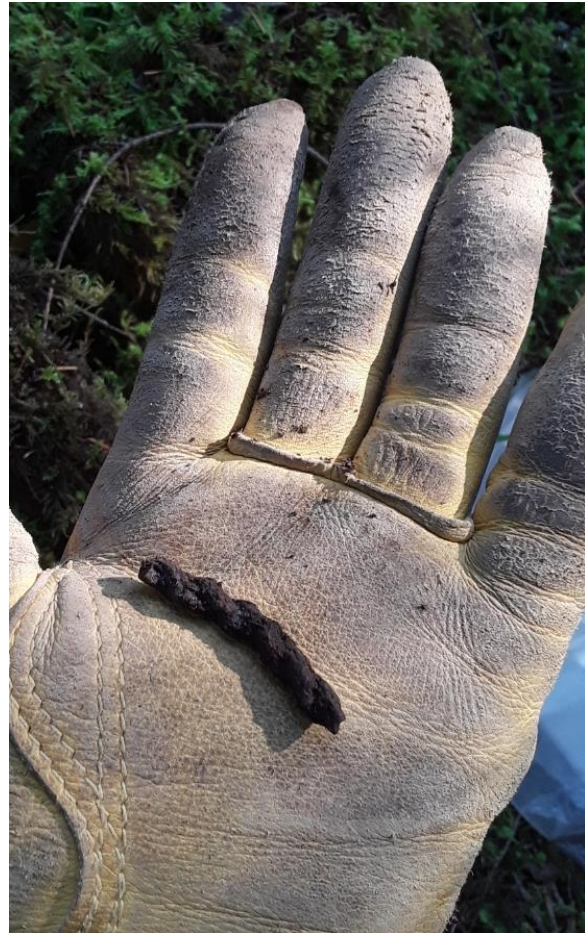
Figure 17. Twisted wire from ST-8. Likely from a telegraph line or historic fence.

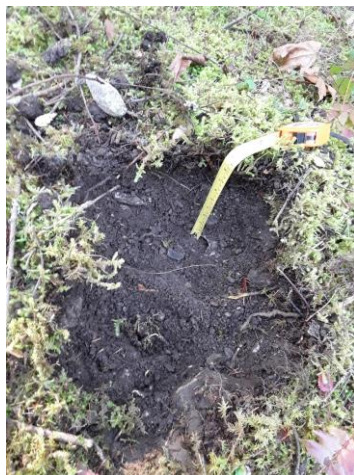
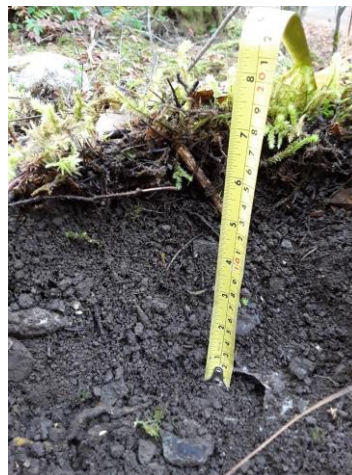
0 to 20 cm dbs
South wall.

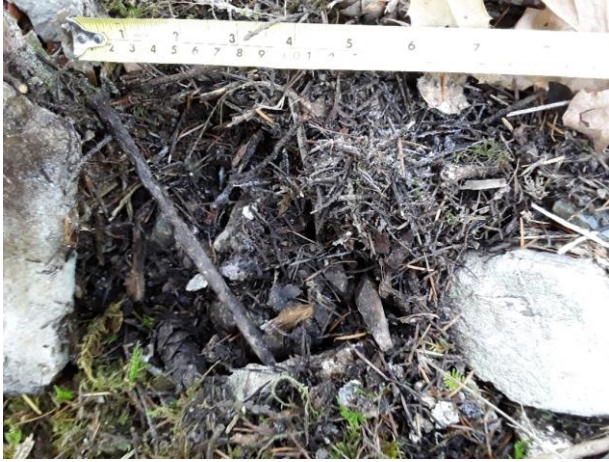
ST-3	Shovel test	2019-11-29	Positive	462125.23	5369904.02	30 x 30
------	-------------	------------	----------	-----------	------------	---------

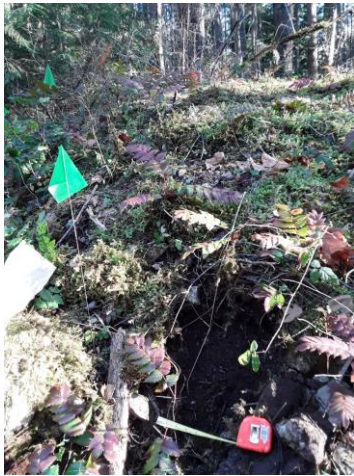
Photo taken facing east.

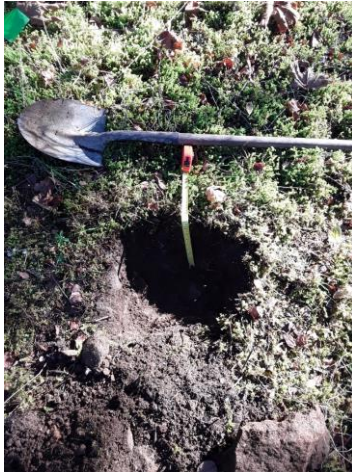
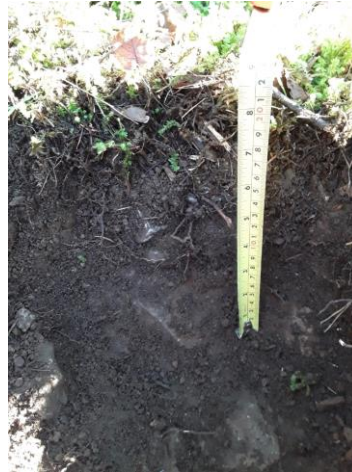
0 to 21 cm dbs
Photo taken facing east.

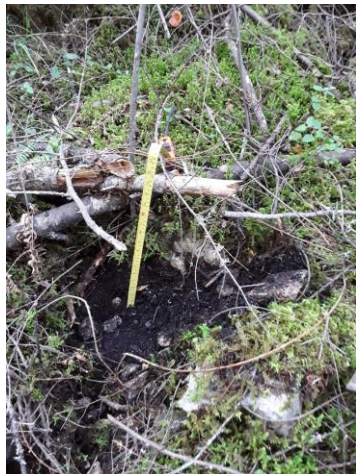
Photo taken facing south.

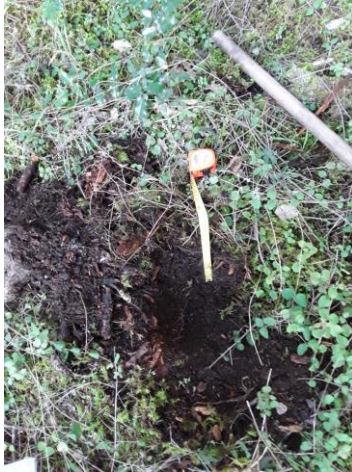
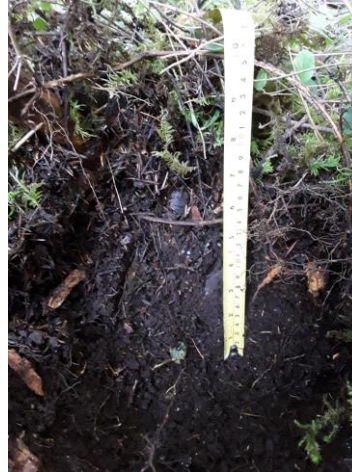
0 to 20 cm dbs
North wall.

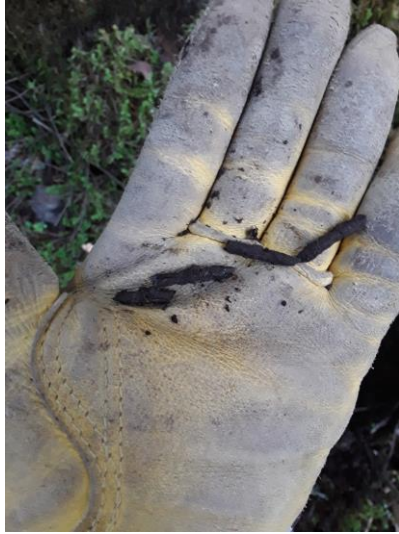
Pieces of metal wire.

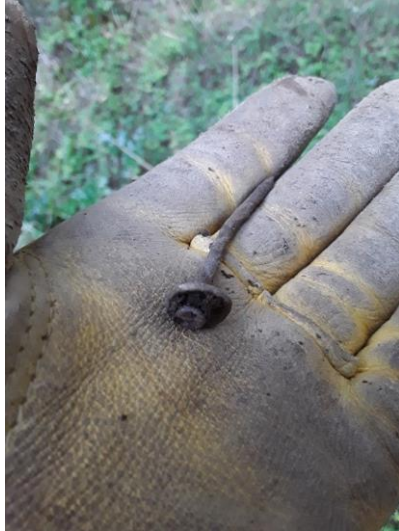
Nail with washer/collar.
