The Highlands Lime Kiln: A Rare Survivor

Concept Plan for Presentation and Interpretation
for the Lime Kiln in the District of Highlands.
Stuart Stark Heritage Consultant September 2016

The Highlands Lime Kiln – A Rare Survivor

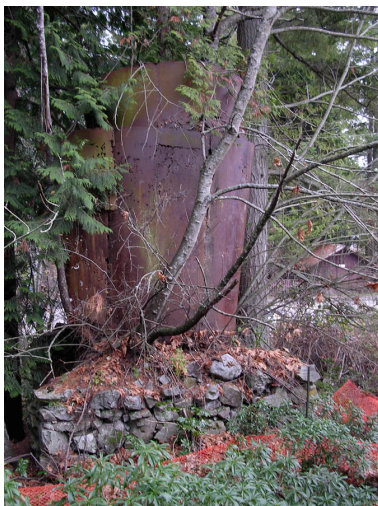
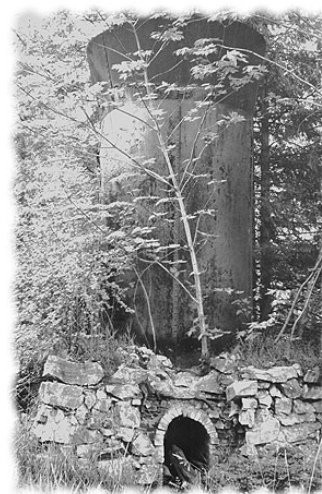
The only other known extant lime kiln in Greater Victoria is located on Hart Road in View Royal. It retains its metal stack surrounding a circular brick structure.

Hart Road Lime Kiln: Left: Stuart Stark photo 2008

Right: Robert Duffus photo 1977

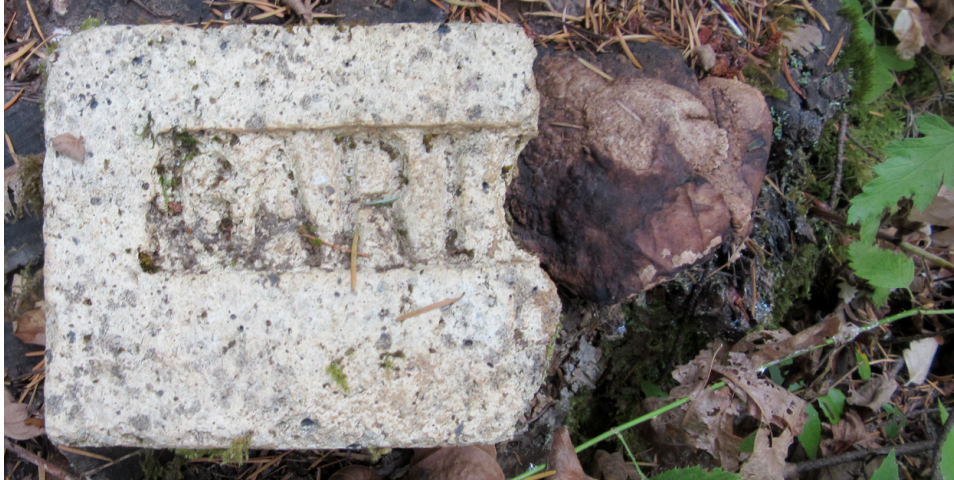
A broken brick with the partial embossed name “GARTCRAIG” from the Aldermere (Highlands) limekiln. Photographed September 1, 2016.

Around the site of the Highlands lime kiln, and among the rubble, can be found yellow firebricks. Probably from the collapsed chimney of the kiln, they can be identified, and add further information about the kiln and its possible dates of use.

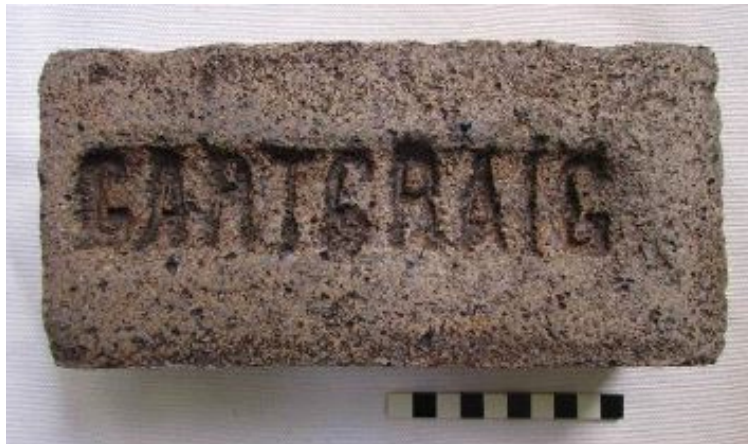
Illustration of a whole GARTCRAIG firebrick found in Buenos Aries, Argentina. They were manufactured in Scotland between 1876 and 1927, in an area northwest of Glasgow, bordering the Monkland Canal, near the village of Ruchazie.

These bricks were shipped all over the world, including California, South America, Australia, Hawaii, etc. and were particularly suited to limekilns.

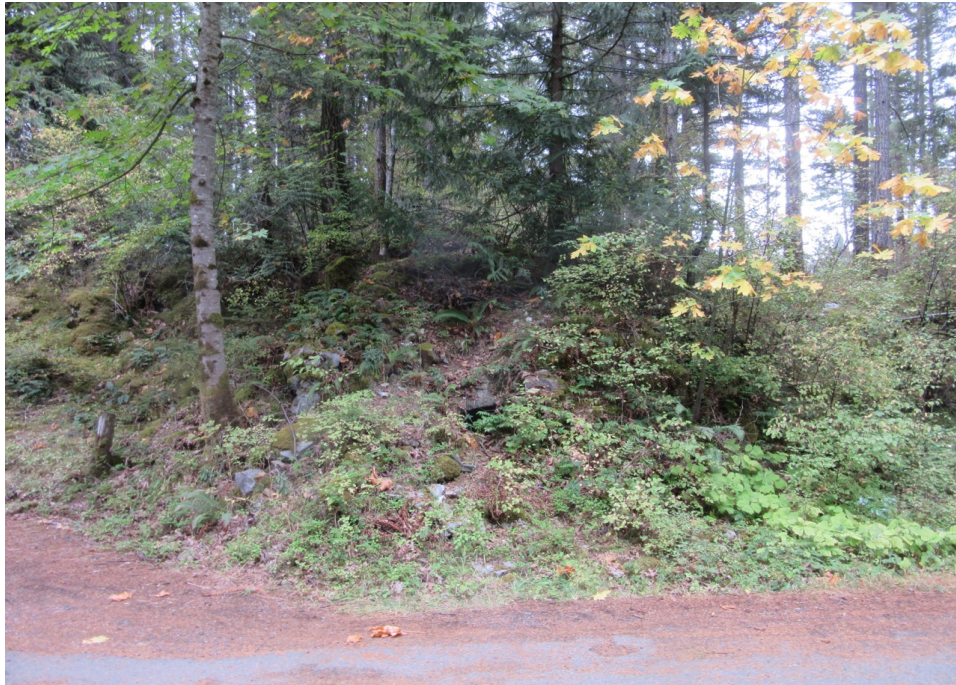
Current appearance of the Lime Kiln on September 1, 2016.

Currently, there is damage happening to the kiln structure. Trees have grown up on, and near, the structure itself. Their roots are damaging the integrity of the structure. Therefore, certain trees need to be removed to prevent further damage. However, the roots should **not** be removed before an archaeological study is undertaken.

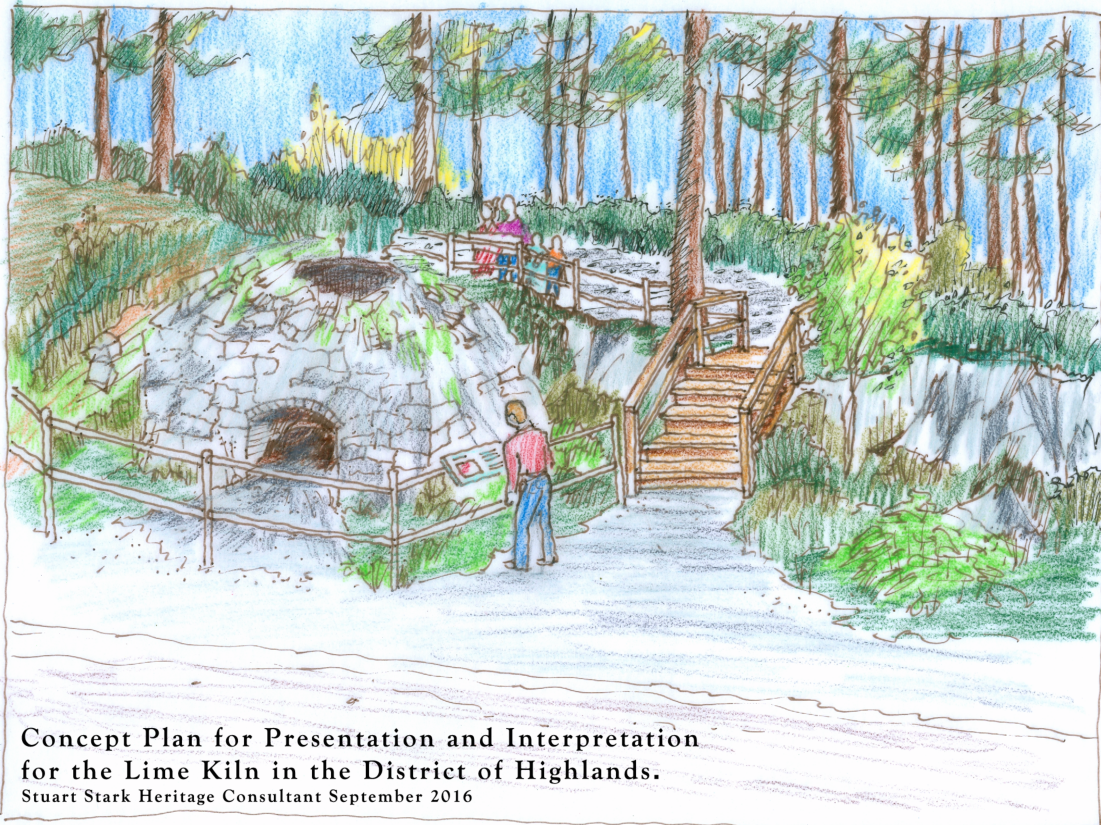
Concept Sketch for presentation of the Lime Kiln as a Historic Site

Visitor access to the Lime Kiln is an important consideration, should it be conserved as a historic site. It will require conservation and preservation work to ensure its survival into the future. Ensuring a reasonable protective buffer zone – as outlined in this report – will allow such preservation work to be accomplished.

The buffer zone will also allow visitor access, while protecting the lime kiln from direct wear and tear. Simple signage can educate visitors about the historic importance of the kiln, explaining its history and how it was used.

A wooden staircase would allow visitors access to the top of the kiln, where the ‘quarryman’ used to unload limestone from a wagon, and load it into the top of the kiln. Another sign up behind the kiln could explain the quarrying and burning process.

Providing visitor access would entail keeping them off the kiln itself by the use of simple fencing. Because of the change of elevation, with the kiln being built up against the rock face, visitor access to the top of the kiln would be easily provided by a simple wooden staircase, connecting to a gravel or bark-mulch pathway at the top and bottom of the stairway. It is very likely that such a rough staircase existed while the kiln was in operation, to allow quick access for the ‘burner’ to assist the ‘quarryman’, or vice versa.
